International Symposium on Hydraulic Structures

Managing Dam Safety Risks Related to Hydraulic Structures

W.R. Fiedler¹

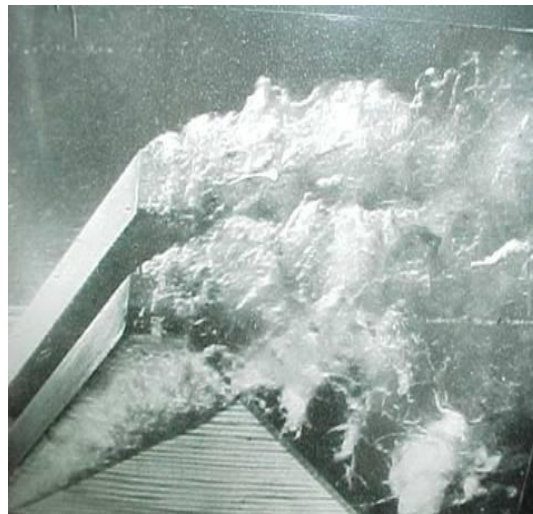
Figure 4. Cavitation Created in Low Ambient Pressure Chamber

Cavitation is the formation of vapor cavities in a liquid. Cavitation occurs in high-velocity flow, where the water pressure is reduced locally because of an irregularity in the flow surface. As the vapor cavities move into a zone of higher pressure, they collapse, sending out high-pressure shock waves (see Figure 4). If the cavities collapse near a flow boundary, there will be damage to the material at the boundary. Cracks, offsets, and surface roughness can increase the potential for cavitation damage. The extent of cavitation damage will be a function of the cavitation indices at key locations in the spillway chute or tunnel and the duration of flow. If the spillway lining is completely failed, the spillway foundation will be exposed, which can lead to scour and headcutting or expansion of the eroded area. These mechanisms could lead to breach of the reservoir. In most cases, this failure mode is unlikely to progress to the point where dam failure occurs due to the long flow durations that are required to cause major damage to concrete linings.

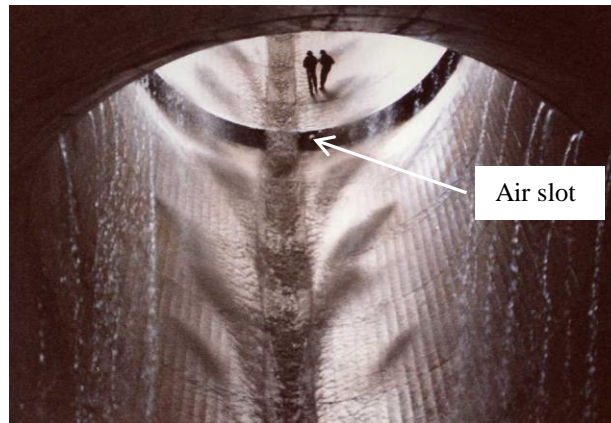
Figure 5. Air Slot at Glen Canyon Dam

The 1.2- by 1.2-meter air slot at Glen Canyon Dam extends over the lower three-quarters of the tunnel circumference, which ensures that adequate air entrainment and good distribution of the entrained air occurs in the flow.

An effective means of mitigating the potential for cavitation damage is to entrain air into the flow. This dramatically reduces the damage that can occur on flow surfaces. This is typically accomplished by separating the flow from the flow surface (through the use of a ramp) and then introducing air on the underside of the flow jet. An example of this is shown in Figure 5, which shows the air slot installed at Glen Canyon Dam.

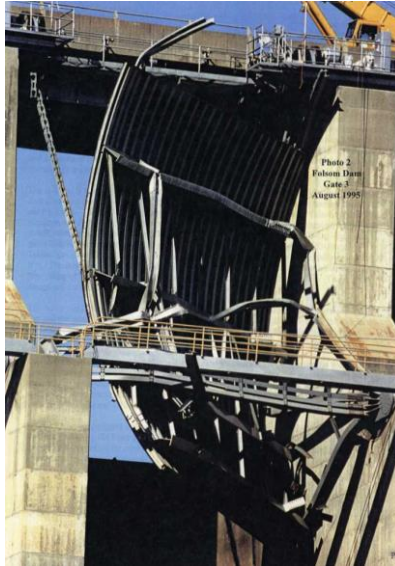
Figure 6 – Failure of Radial Gate No.3 at Folsom Dam

Gate No. 3 was being operated at approximately 8 a.m. on July 17, 1995, to maintain flow in the river during a powerplant shutdown. As the gate was opened, it was allowed to stop at 15 cm automatically and again at 30 cm. The auto-stop function was overridden (normal procedure) with no stop being made at the 60-cm level. As the gate opening approached 73 cm, the gate operator felt an “unusual vibration” and he stopped the gate hoist motor. As the operator turned to check the gate, he saw the right side of the gate swing open slowly, like a door hinged on the left side, and saw water pouring around both sides of the gate leaf (see Figure 6). The time from the operator’s initial awareness of the vibration to observing gate displacement and uncontrolled flow of water was estimated to be no more than 5 seconds.

Following the failure of Gate No.3, a multi-disciplinary, multi-agency forensic team was formed to investigate and determine the cause of the failure. The team identified the two main causes of the gate failure as insufficient stiffness and strength in critical structural gate arm members and increased trunnion friction by corrosion of the steel trunnion pins.
